Report for March 27, 2017

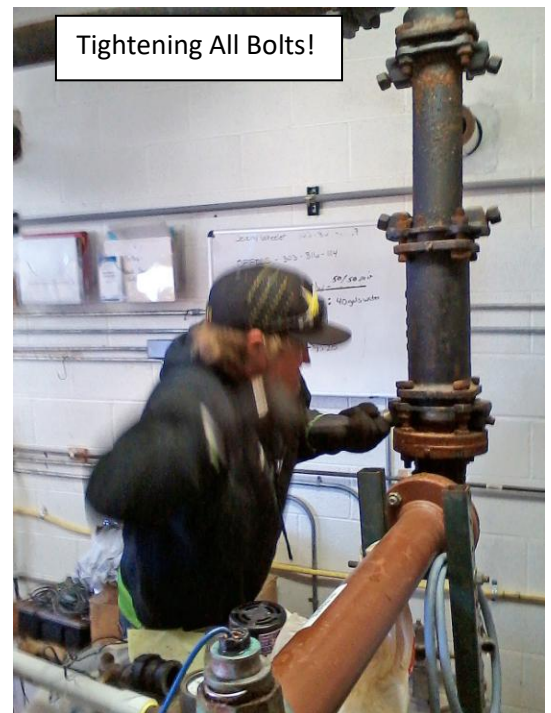
On the 9th, Jim Petrain and an associate came to remove the old Ductile Iron pipeline that had conveyed raw well water to the bag filters in the GAC building. I called Bob and we agreed it would be appropriate to shutdown the pump and valve off the remaining Ductile Iron pipeline given that no megalug bolts had been snapped off although we assumed they had been tightened to perhaps 90% of the snap point force. Because, the guys would be dismantling the other pipe only inches away, I also cracked the drain valve on a bag filter to take the pressure down from 95 to about 20 PSI. Then they went to work dismantling the other pipe, and I started to make a small repair on a PRV. Then Jim's associate said "...I just unscrewed a megalug bolt with my fingers." That was a heart stopping moment. It appears that the bolts were tightened very inadequately, very scary indeed!

I had them snap all of the megalug bolts and tighten all of the other bolts, most of the bolts needed tightening!

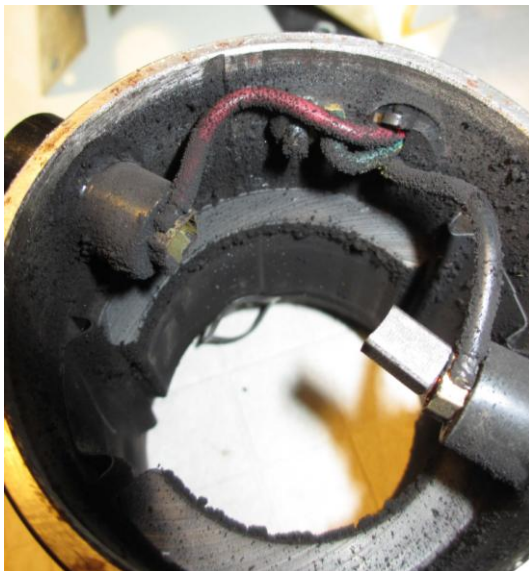
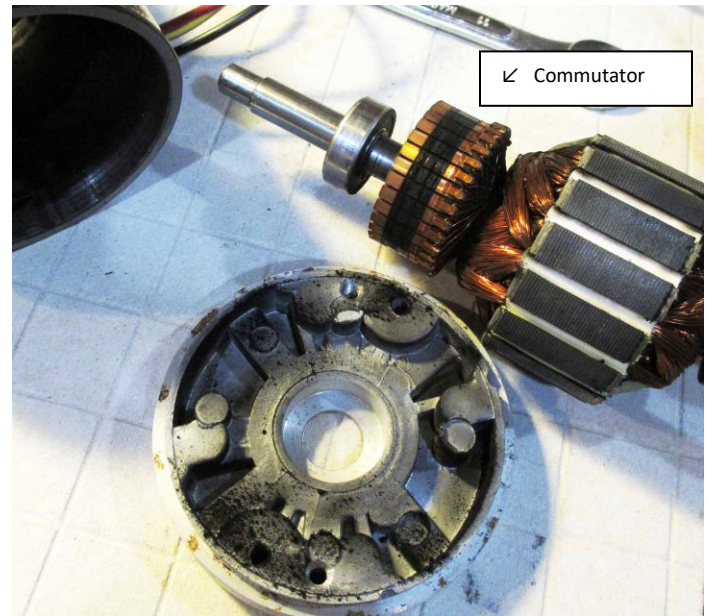
On the 23rd I went to the tank to check on the CL-10 and found the pump had stopped working. I took it home, dismantled it and found one of the motor brushes had burned

up. Fortunately the motor was easily dismantled, and cleaned. The commutator was burned but # 600 sand paper and a drill brought that back. And fortunately

Woodland Hardware had brushes, like the ones below. Unfortunately the springs were too long and that modification took at least an hour. Including a trip to Woodland Hardware the \$1000+ pump was back in service in just over 4 hours. With luck, this pump will give us another year or more. Meanwhile I have found better pumps at nearly half the cost.
