Kent Brady, Project Manager

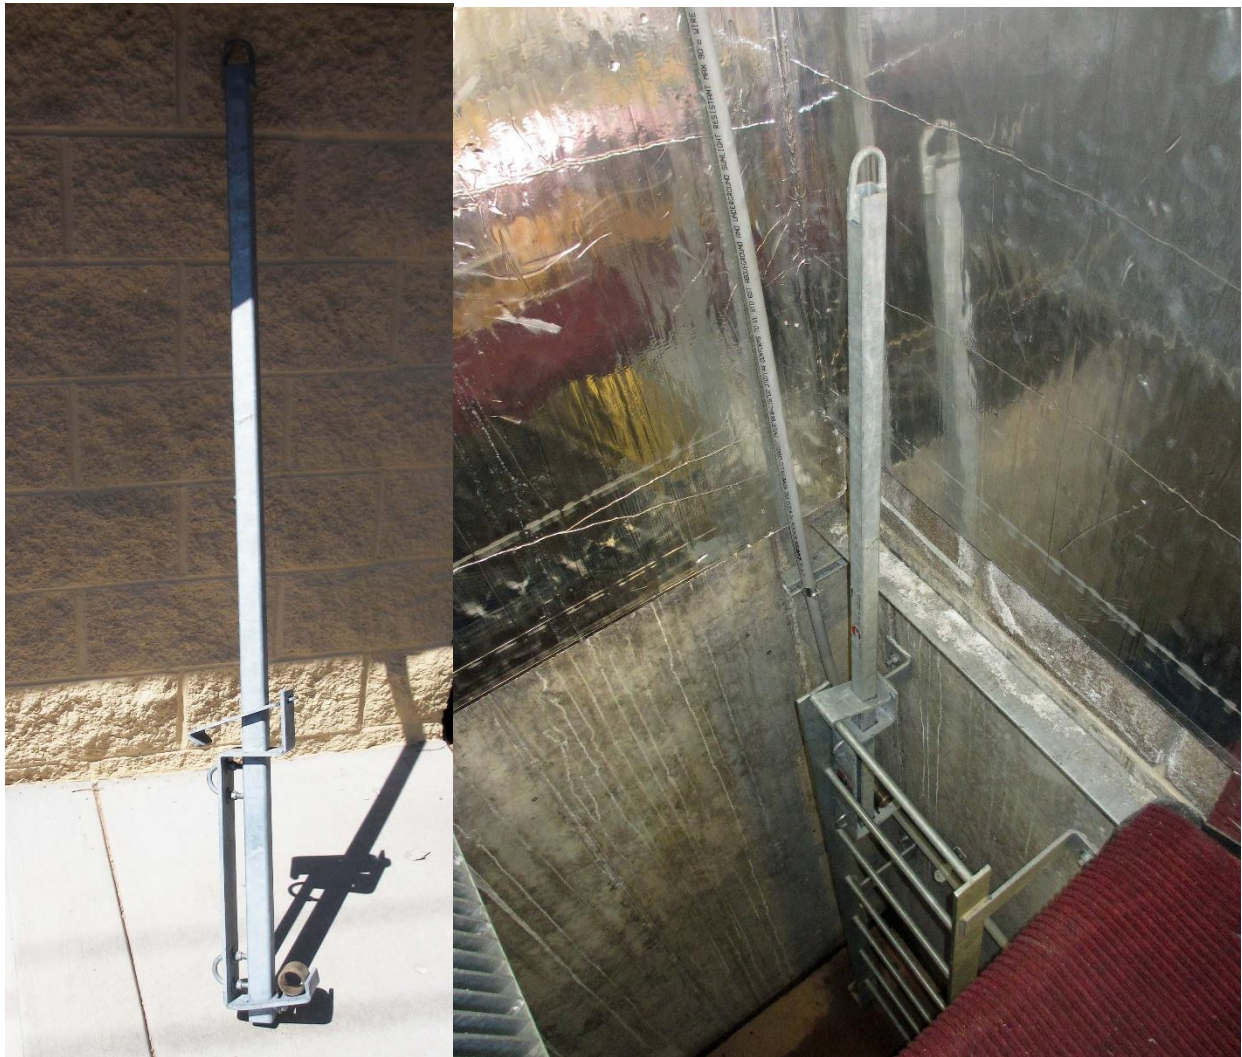
**Tank Ladder:** The ladder in the tank vault does not extend above the mezzanine floor making it difficult to descend or extricate oneself from the lower level. I assumed that Melanie had made a mistake but evidently that’s a common problem and Bob had the common fix in his garage. He brought that last week. It is a spring-loaded extension that can be brought up above the mezzanine to aid access and egress. The support can be pushed below the floor so the hatch can be shut.

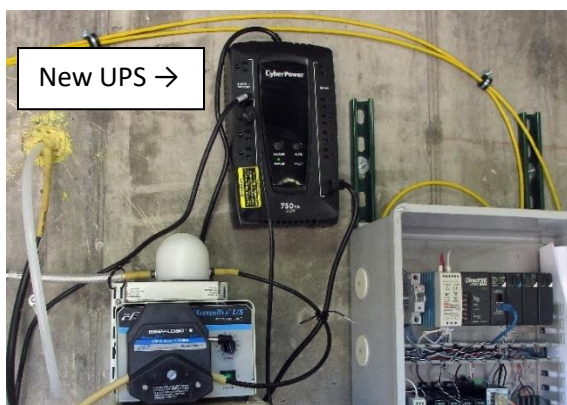
**Tank Uninterruptable Power Supply:** The tank vault can become humid during the summer and as such some condensation fell on the UPS that backs up the electronics there including the tank level sensor. When the UPS went out that took out the level sensor and shutdown the pump. I got a multi outlet surge protected power strip from home and had the system equipment back on-line. I ordered a new UPS and I installed it on Tuesday the 22<sup>nd</sup>. See the photo on the left.

During the summer, the tank should be inspected at least twice a month for excessive moisture – it should also be inspected to see if the rubber hose in the peristaltic pump needs replacing. I have installed a large blower which will dry the floor in about an hour. In the photo above you can see water on the floor at the foot of the ladder. This photo was taken after installing the UPS while running the blower.

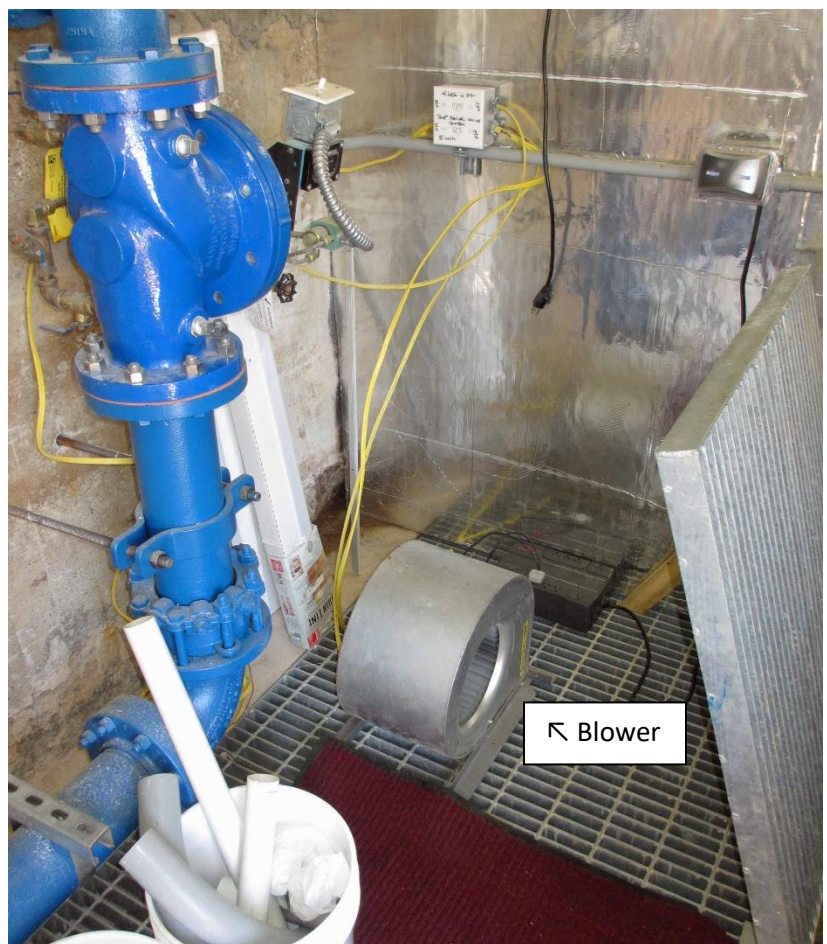
Incidentally, the 4” blue pipe was installed to flow water from our wells into the tank from the top so as to create a circulation and flow through the tank to the exit near the floor. The design assumed we would install a 4” line from the Water Plant to the tank for all water production. Further it was assumed that this 4” line could be drilled together with a new 8” water main from

the tank to the vicinity of the Water Plant where it would feed the existing 6” line to Navajo Tr. in the Southern System. Ultimately these plans proved to be too expensive. With the plumbing in the tank vault in-place we began thinking about how to achieve our objectives without the benefit of the dedicated 4” production line. With help from Treatment Tech

and others we developed a simple plan to modify this plumbing to do just that. And thereby freeing up an 8" pressure regulating valve we could use for a new 6" connection to the City main in Piute Tr.

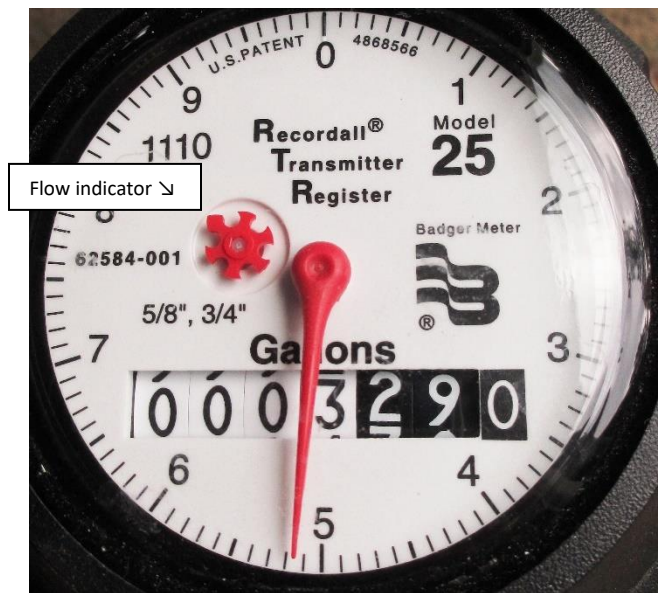
At this point while writing I got a phone call and access to 755 #3 Apache, one of the condos at 67, so I went to fix that meter. The meter was working OK even with just a slight trickle of water from a faucet, the flow indicator turned smoothly. The problem was a wiring issue. After the repair, the programming tool reported the current meter reading and it should begin reporting the reads twice daily to Pathway Reads our water data service provider.
