Report for September 10 2017

Kent Brady, Project Manager

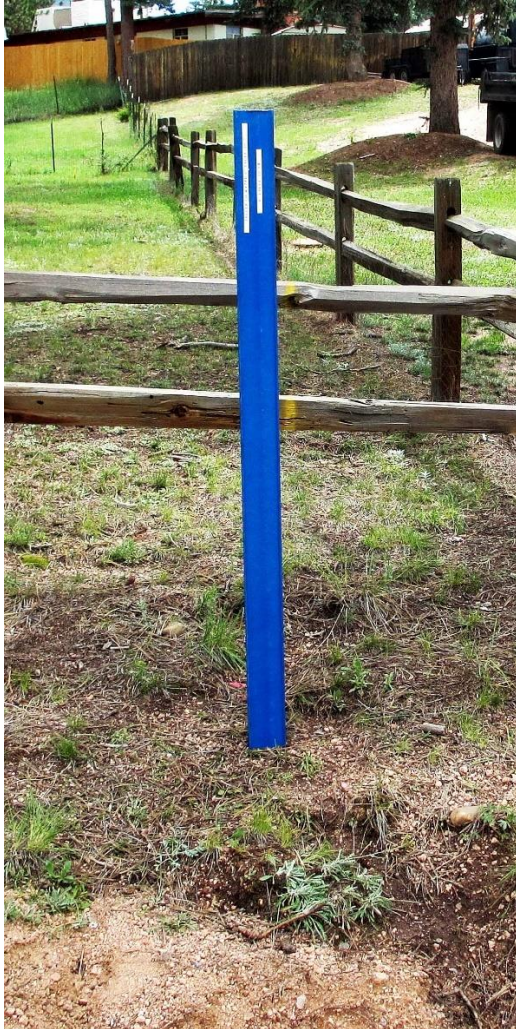
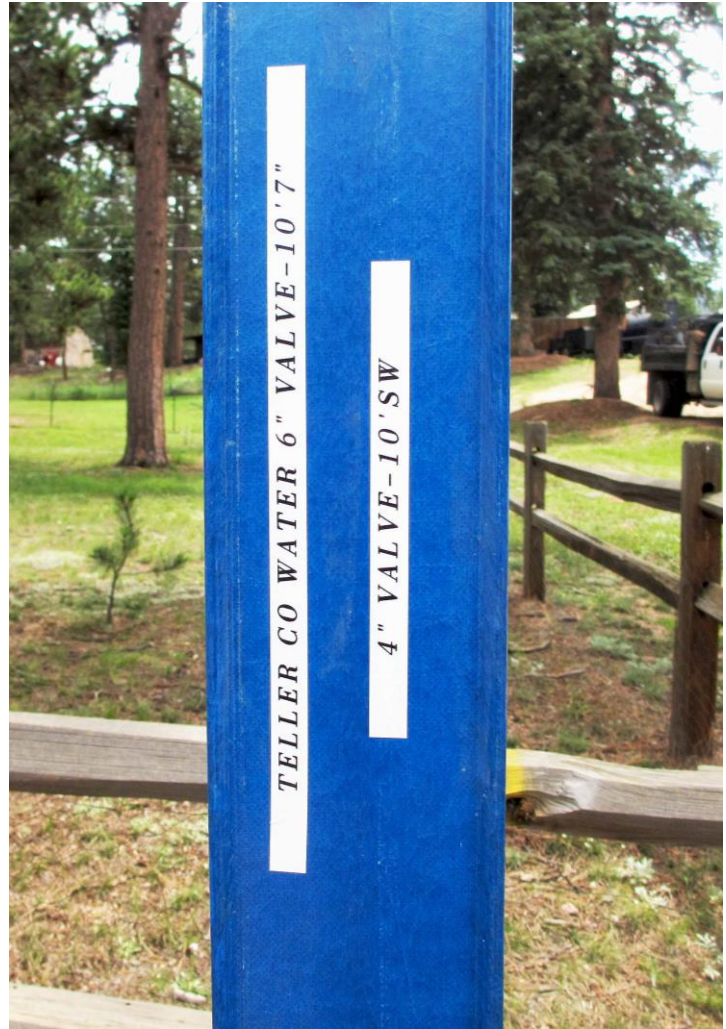
I had intended to include photos of the valve markers in the last report, here is what I had referred to:

The objective is to help an operator get to a valve buried in a dirt road as quickly as possible during an emergency.

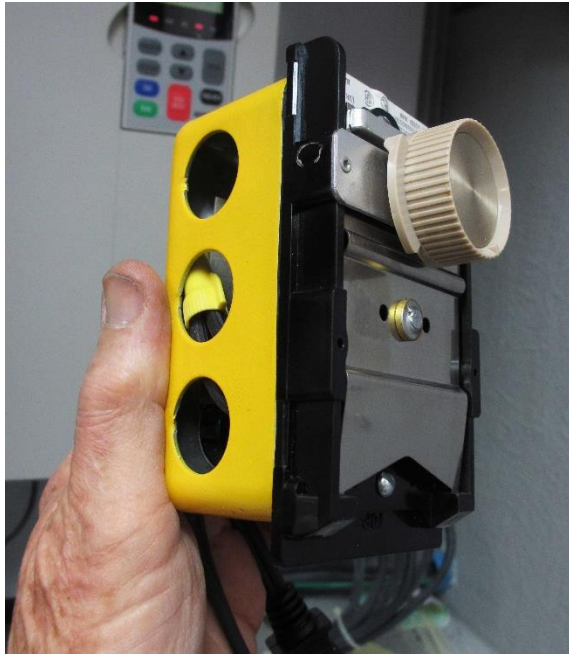
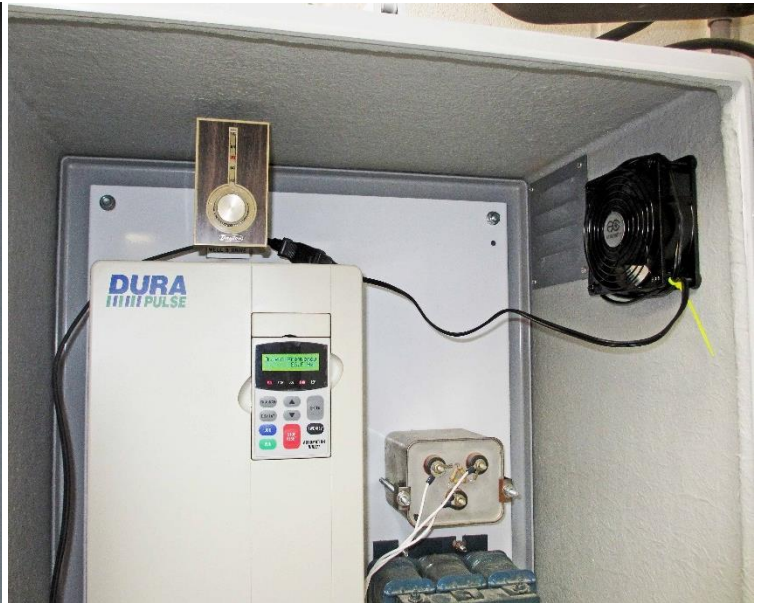
While I was at the Water Plant I noticed that the Well #9 VFD cabinet cooling fan was making a loud grinding noise. I removed the old "muffin" fan which I had donated several years ago, it was very hot! I ordered a new fan and I installed it today including a thermostat which Dan had donated. The thermostat will shut off the fan when the pump is off and it will prevent the fan from operating during the winter when the Water Plant is cool/cold. I installed another thermostat Dan had donated to shut off the cabinet cooling fan at Well #8 some time ago.

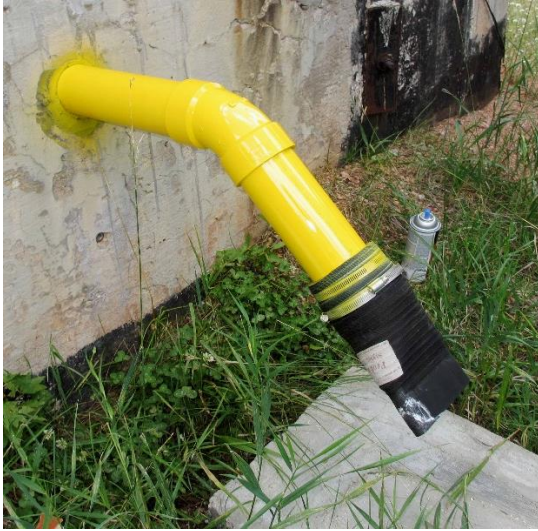
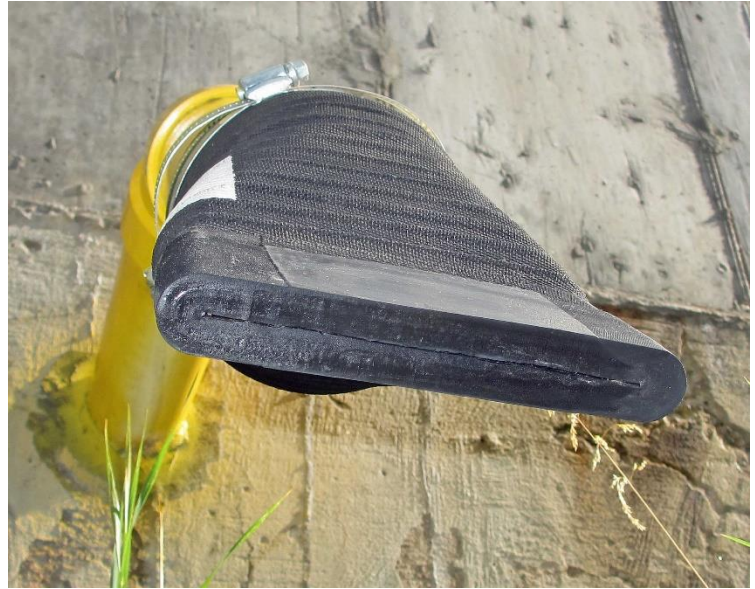
The tank overflow incident reminded me that this had happened once before after the tank was rebuilt and returned to service mid-January 2012. In that event it was apparent that the over flow pipe needed modification so it would drain more efficiently. We employed a synthetic rubber "duck-bill" valve on the pipe because they open with hardly any pressure and otherwise they close to prevent even insects from gaining access to the tank. But, the exit flow was insufficient to prevent the tank from continuing to fill albeit gradually, depending of course on the rate of production. The photo on the right is the original over flow drain. I have modified the pipe as indicated the in photos on the next page. This change should improve the flow significantly.

In the photo on the right you can see the thin line which opens to allow water to. I painted the pipe to protect it from ultra violet light. The drain is located at the north-west end of the tank.
