Report, May 30, 2017

Kent Brady, Project Manager

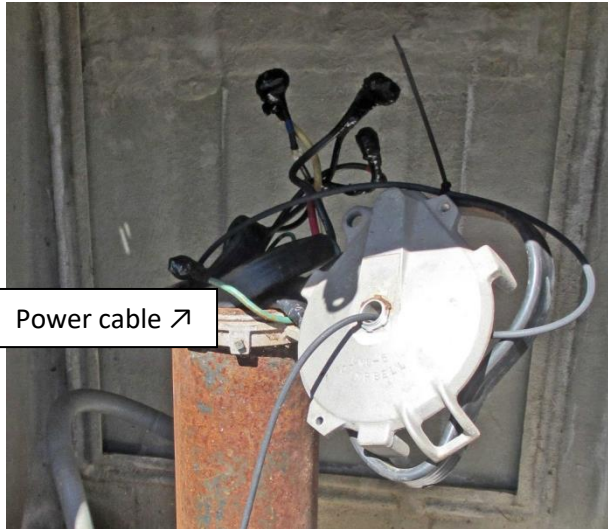
On the 1st we had a surprise water system inspection by CDPHE. Almost all was found in order. There were no significant issues, in fact they were even complementary! However, the inspector wanted the cap on Well#9 put back in place. After the lightning strike last year which cut the power and level sensor cables we were

unable to get the power cable back down the pipe to replace the cap. The well pipe and cables were wrapped in plastic to prevent anything getting into the well pipe and of course the wellhead is enclosed in a locked fiberglass security cabinet. With the aid of a crowbar I managed to force the cables down the pipe (photo to the left) and secure the cap. The CDPHE officials were sent a photo of the secured cap as requested.

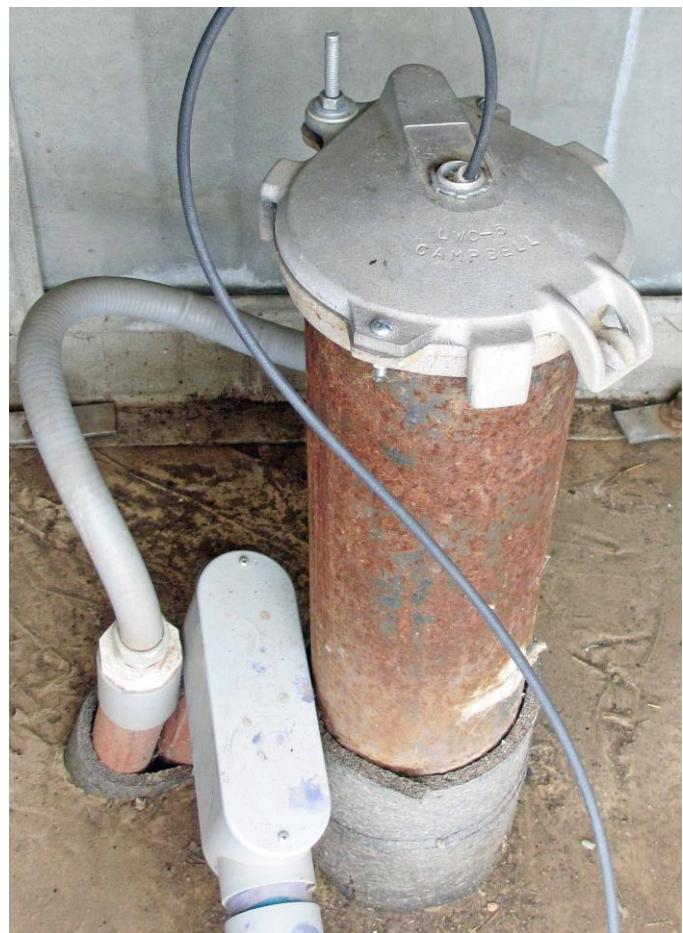
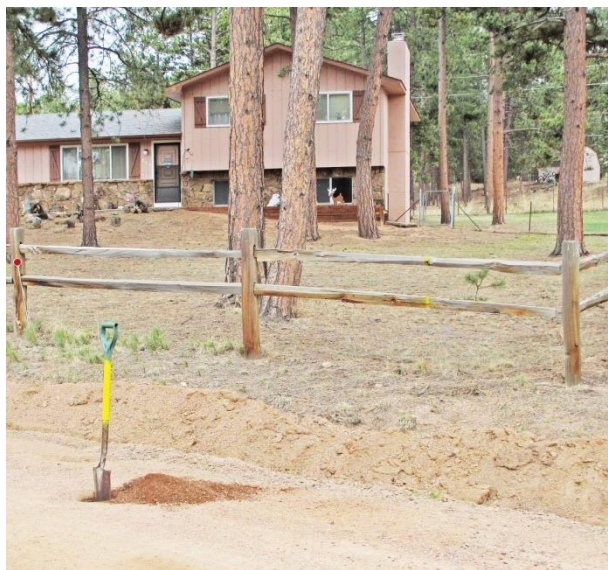
That afternoon I managed to locate and expose the west bound valve at the Tee on Sunnywood Ln. from the Hopi Tr. line with the help of a neighbor. The discovery of the location of the line from Hopi Tr. into Sunnywood was the result of another good neighbor who knew where it was. On the 5th Jim and I tested the valve and it appeared to be working like new. This is a 6" valve

on the 6" line across the east end of Sunnywood to Lovell Gulch, see photo on the left.

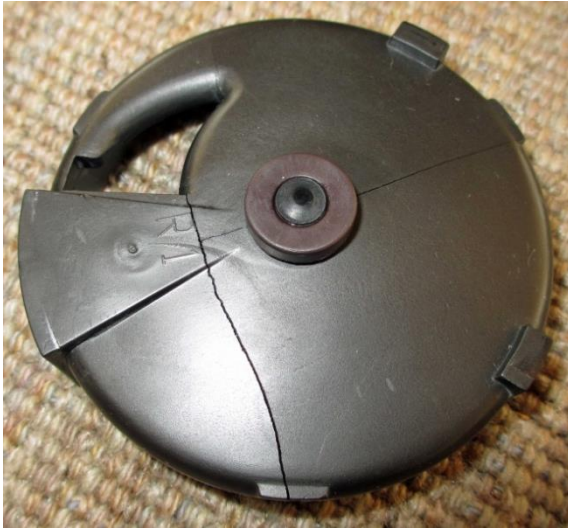
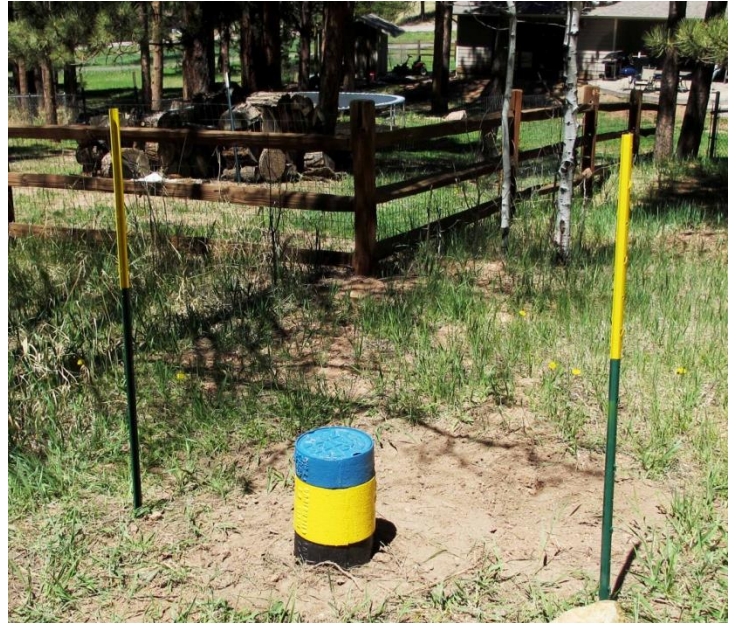
At about this time I began repairing defective domestic water meters. This is a tedious job. First it takes time to contact and schedule a visit and then the repairs are each unique experiences but we are making progress. Some of the internal plastic parts of these meters were found broken and badly worn. The one below was badly cracked:

To date, 8 meters have been repaired but it is beginning to look like I have to learn how to program the reserve Hexagrams to replace not responding units.

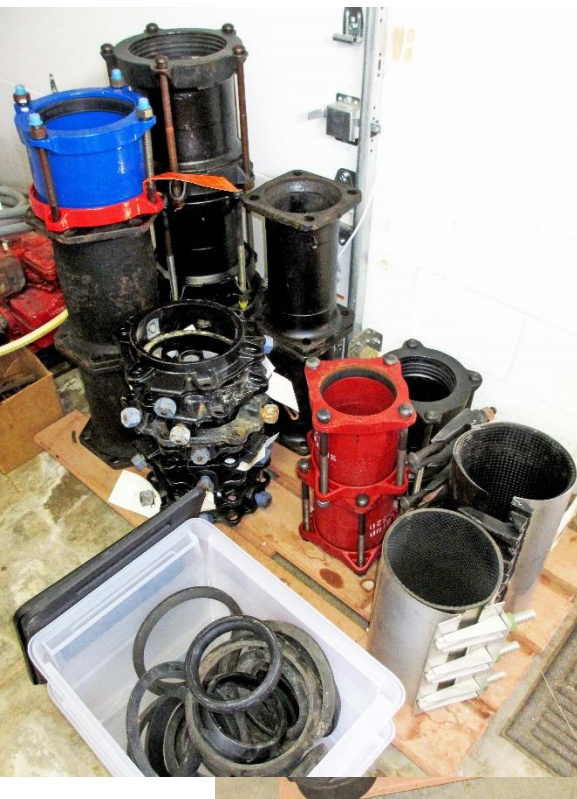
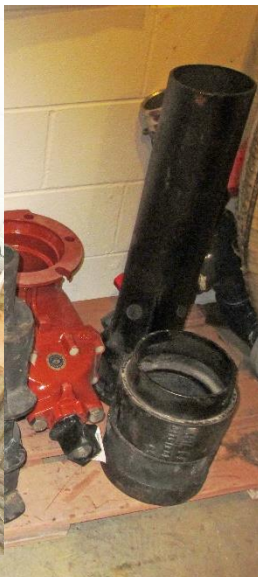
I have also begun buying and digging parts out from under stuff in our shed so we have all it takes, as far as possible, to repair the next water main break and install valves if desirable.

We have 3 kinds of pipe and a total of 7 pipes and sizes but we have a fair share of the parts in stock although they need cleaning and positioning. I have always pushed this off for a time when we would have a proper storage facility but in the interim two pallets, one in the GAC and the other in the Treatment buildings will have to do for now.
