Sunnywood Ln. Water Main Break

Chippewa Tr. Service Line Break

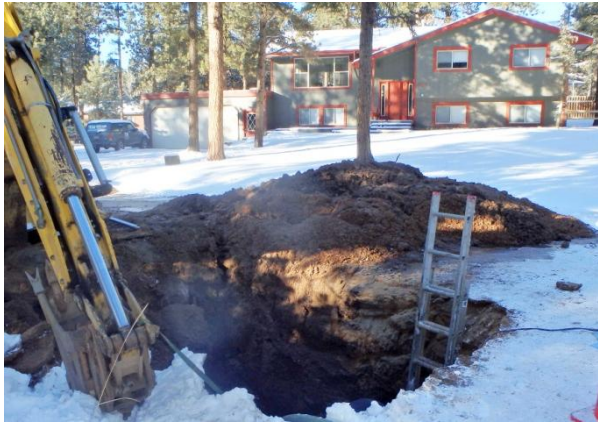
Several weeks ago we detected a significant increase in demand or in our leaks. All water systems leak it's just a matter of percentages. Then overnight Wednesday the 14th the loss rate increased alarmingly and by Thursday evening we began having difficulty maintaining our tank at better than 9 feet with Wells #8 and 9 producing more than 80 GPM (gallons/minute). Well #8 is our largest well but of late its intermittent use had drawn in a significant level of silt which plugs our 10 micron bag filters – three large units in parallel – so I was in the water plant changing out the filters while taking 125 GPM from the City of Woodland Park to

help get the tank back up above 10 feet when I got a call from 600 Sunnywood Ln. the leak had broken through to the surface opposite 680 Sunnywood Ln.

Water was flowing into and down the ditch toward 67 some 300 to 400 feet east of the break on this line that occurred back in January.

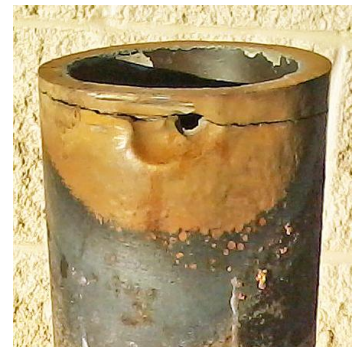
1972. These are very high quality, exceedingly durable pipes with a rubber like lining and an exterior coating that is highly rust resistant. The wall of this pipe is about ½ inch thick! Unfortunately, this pipe was poorly "bedded" in 7' deep ditches throughout much of Sunnywood. Over time the poor installation work and the consolidation of the road bed by traffic has placed this pipe under enormous stress. So, just as we saw with the January break, this break was the result of a crack that very nearly broke the pipe apart. As water began seeping through the crack at something like 90 PSI it quickly scoured a significant hole.

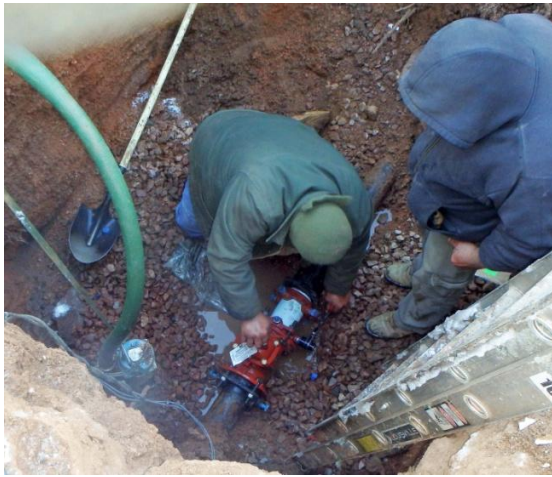
Nearly 2' of pipe was cut out of the line including the break and a valve was inserted in that space to

provide us with greater control of water flows in the future on Sunnywood Ln. As a matter of fact, we plan to install a "lateral" that is a 6" pipe to connect the Apache Tr. water main to the Sunnywood Ln. water main. This new valve and the valve we installed while repairing the January break will isolate the section of the water main where the lateral will enter the Sunnywood Ln. water main so that work will not require shutting down the whole of

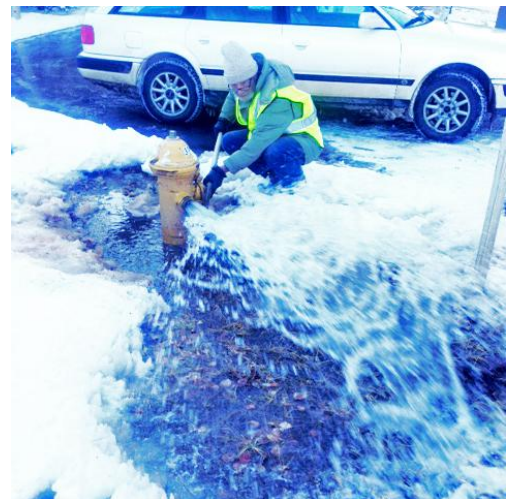
The photo to the right was taken while we were flushing the Sunnywood Loop hydrant. Unfortunately we flooded the driveway of the home next to the hydrant in spite of our best efforts to deflect the flow into the ditch. We put a lot of ice melt on the drive the next morning having made an ice skating rink of the driveway.

During the flushing, we discovered that 2 of the 5 hydrants in Sunnywood have become inoperative. The one on Sunnywood Ln. had been leaking and was frozen and the other, on Lovell Gulch, could not be turned on. These require maintenance or replacement.

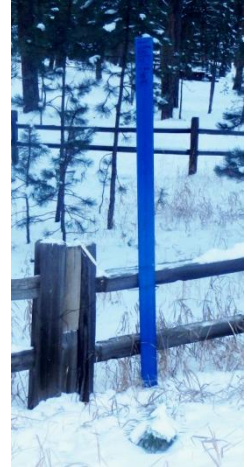
I took the opportunity to set temporary markers for both valves, see photos. I'll drive them in place in the spring. Filling the Sunnywood excavation with dry earth, hauling off the highly saturated dirt, virtually a slurry, compacting the fill and grading the road took until well after 7 PM so work on the Chippewa Tr. leak would have to be pushed off until Sunday. While this work was drawing to a close I worked to remove the valve caps on Chippewa to isolate that leak. They were frozen in place. Unfortunately, the valve above the leak in Chippewa near Kelly's Road was full of water and frozen to an uncertain depth so we could not easily isolate and slow down the leak over Saturday night.

Sunday morning I started in chipping the ice from the valve pipe with a crowbar. It took over an hour to break through the ice at a depth of over 2' so this valve above the leak could be closed. Incidentally, this is the only counterclockwise closing valve in our system as far as we know. With this valve closed and the one where the Navajo Tr. main enters Chippewa substantially closed the excavation could begin Monday morning.

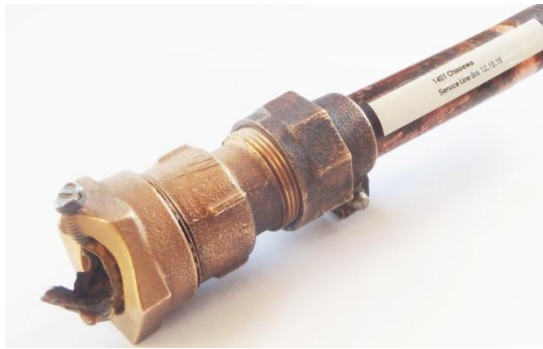
Service Line Issues: In our system as well as that of Woodland Park and Colorado Springs, homeowners "own" their service lines from water mains to their homes. This "ownership" however is not without limits. Homeowners cannot operate their service line valves and they cannot replace, move or upgrade these lines without District approval and oversight. When leaks occur in or by the road before the homeowner's service line valve the District is obliged to take actions to stop the leak as soon as possible and we do. A road side leak can compromise a road and endanger traffic and road damage is considerably more costly to repair. If a service line leak occurs out in a yard and can be shut off by a service valve or if the leak is negligible the homeowner can be given a reasonable period of time to make repairs. This is a more-or-less standard practice of public water utilities. Some systems take ownership of the service line from the main to the edge of a property or to a property's "curb stop." Following an incident several years ago your board decided to take ownership of the bracket (called a "saddle") and ball valve (called a "corporation stop") that is attached to a water main and to which a service line is attached. If the saddle or corporation stop fails, the District will bear the cost to restore service without charge to the homeowner. Beyond this, boards have concluded it would constitute too great an increase in rates to assume responsibility for service lines from the main to a "curb stop" or to a property's edge. The service line, valve and break were excavated. The break occurred where the copper line from the water main joined a very old steel pipe with a brass coupling. The steel pipe had rusted away and dissolved as the result of bi-metal galvanic action. The photo shows all that remained of the steel pipe where it plugged into the brass coupling, just a finger of metal.

Anyone with a house built before about 1980 may have a steel service line. These lines are also referred to

because replacing lines in these locations is far more costly. We urge owners of homes built before 1980 to determine if they have a steel service line and if so to get it replaced as soon as possible because, as in this case, the excavation and repairs we have just made will be charged to the homeowner. Moreover, the homeowner is also responsible for the water loss and will have to pay to re-excavate this site to replace the steel pipe greatly increasing their cost.
