Report for September 10 2017

Kent Brady, Project Manager

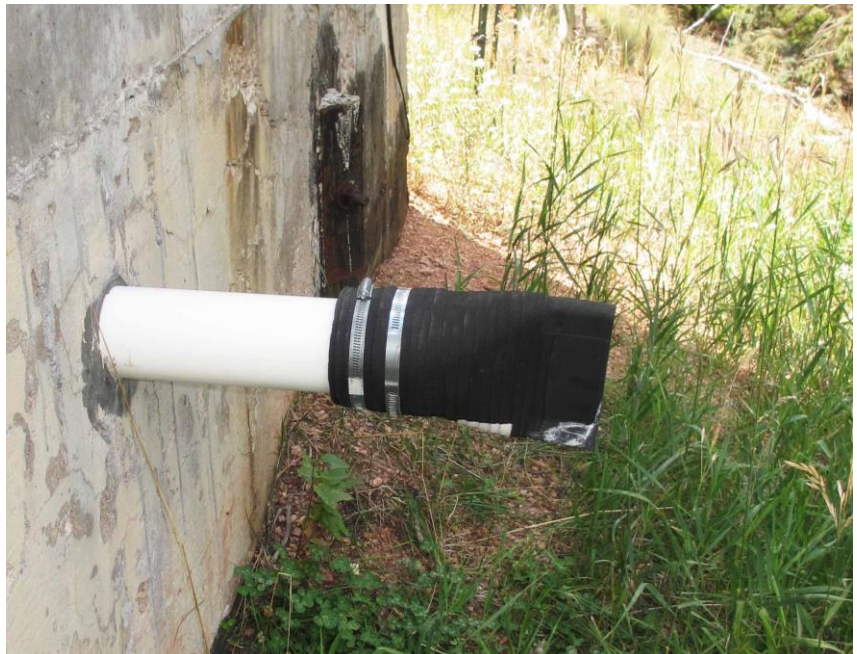
The tank overflow incident reminded me that this had happened once before after the tank was rebuilt and returned to service mid-January 2012. In that event it was apparent that the over flow pipe needed modification so it would drain more efficiently. We employed a synthetic rubber "duck-bill" valve on the pipe because they open with hardly any pressure and otherwise they close to prevent even insects from gaining access to the tank. But, the exit flow was insufficient to prevent the tank from continuing to fill albeit gradually, depending of course on the rate of production. The photo on the right is the original over flow drain. I have modified the pipe as indicated the in photos on the next page. This change should improve the flow significantly.

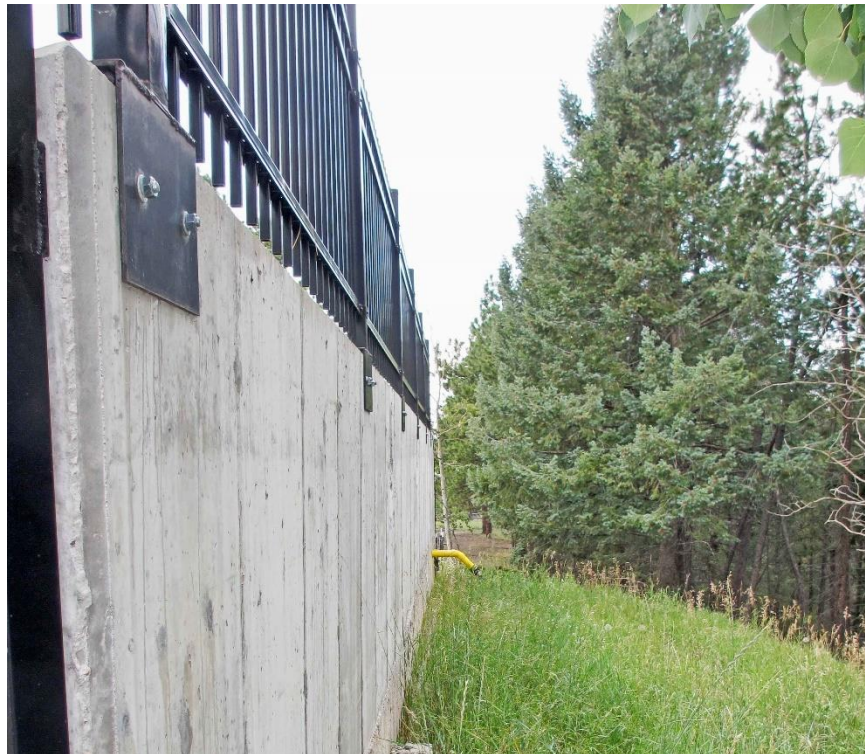
In the photo on the right you can see the thin line which opens to allow water to. I painted the pipe to protect it from ultra violet light. The drain is located at the north-west end of the tank.
